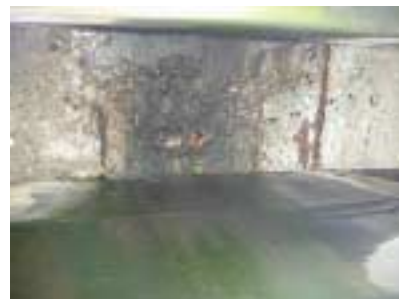
Spall in Soffit at Drain

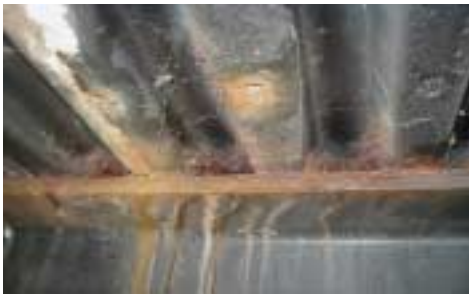
Typical Rust Pack at Steel Girders

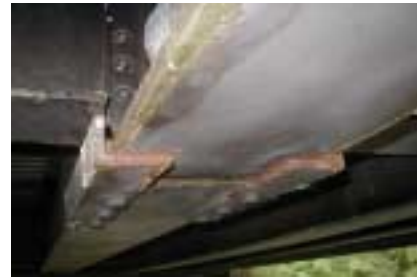
Rust Pack at Pin & Hanger Catchers

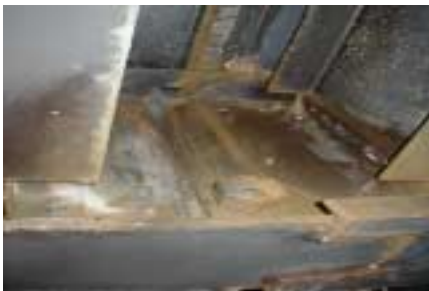
Rust at Pin & Hangers

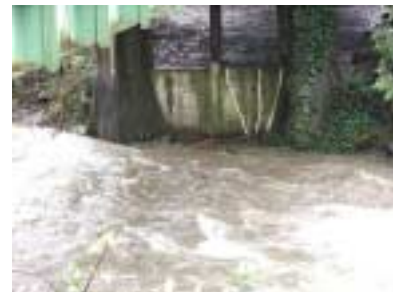
***Web Wall Cracked by Settlement
Middle Column is a Temporary Repair***

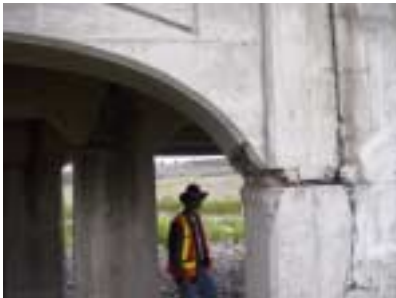
Spalling and Cracking at Bearing

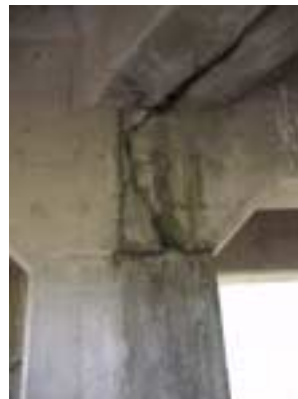
***Cracking
at
Beam Seat***

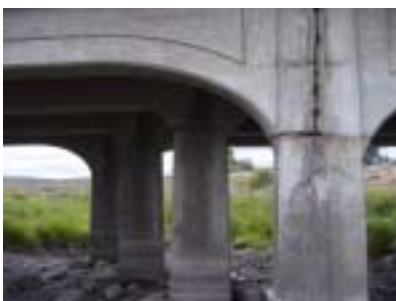
Concrete Cracking in Column

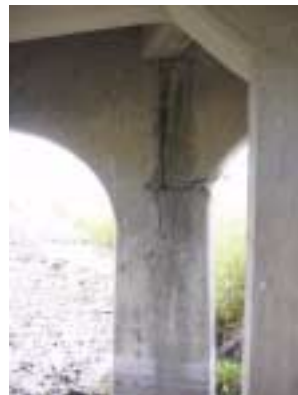
***Cracking
in
Column***

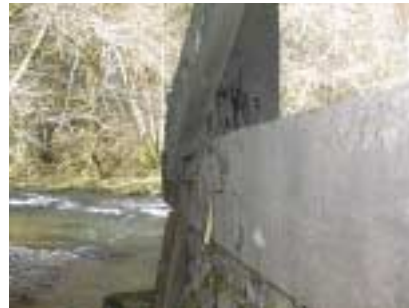
***Another View of Deteriorated
Foundation Materials***

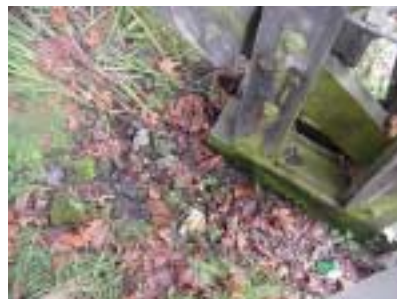
Timber Sill in Contact with Soil

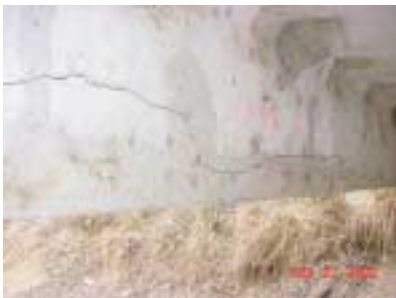
Cracks in Multibeam Web

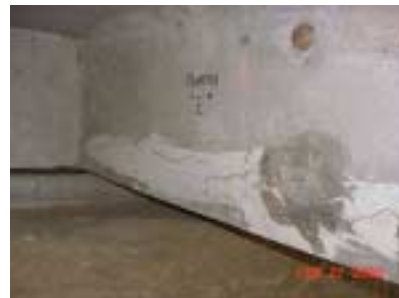
Cracks in Multibeam Web

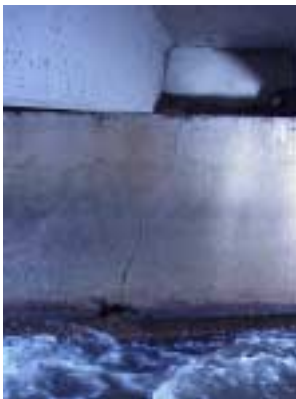
***Crack in
Abutment Wall***

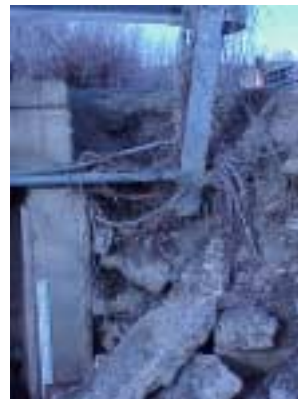
***Erosion at
Abutment Wall***

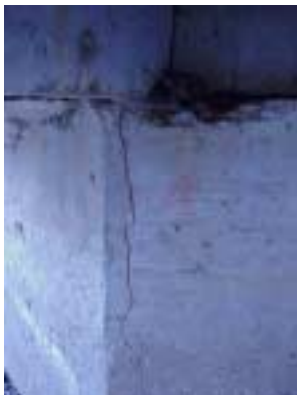
***Crack
at
Girder
Seat***

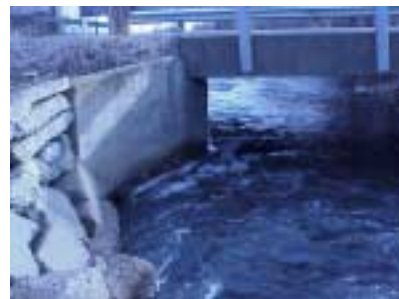
***View Showing Restricted
Bridge Opening***

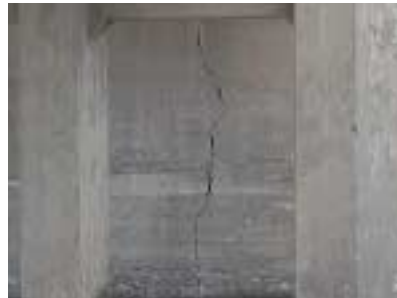
Crack in Abutment Wall

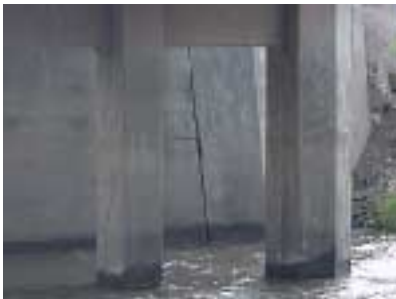
Open Construction Joint

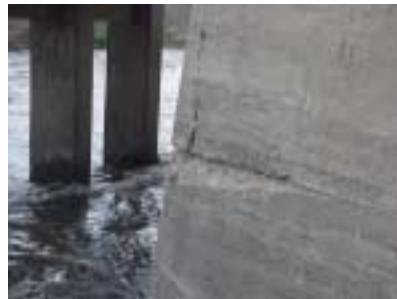
***Cracks and Spalling Abutment
Retaining Wall***

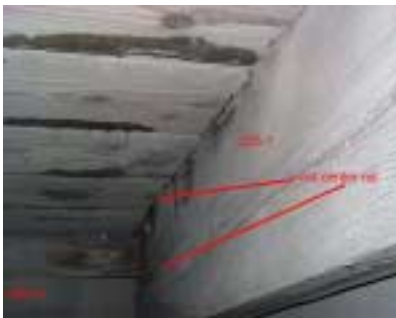
Timber Sawn Girders are Checked and Stained with V-rot

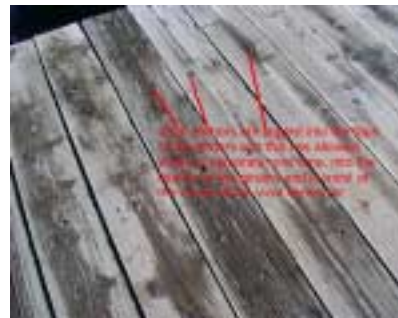
Timber Running Planks are Worn & Weathered

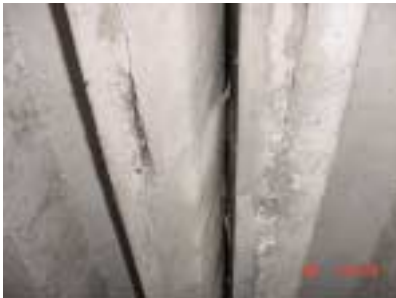
Cracks with Exposed Rusty Reinforcing Steel in Multi-beam Webs

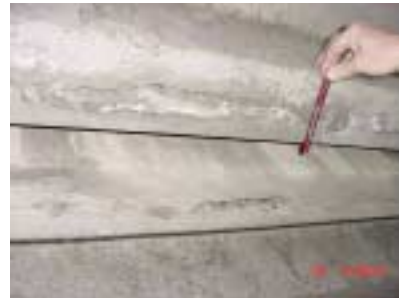
Cracks with Exposed Rusty Reinforcing Steel in Multi-beam Webs

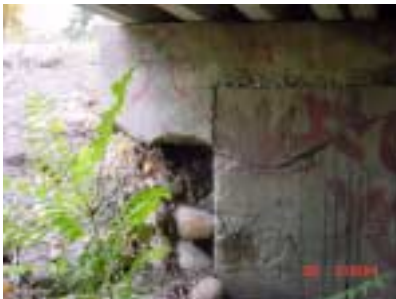
Abutment Extensions and Open Crack

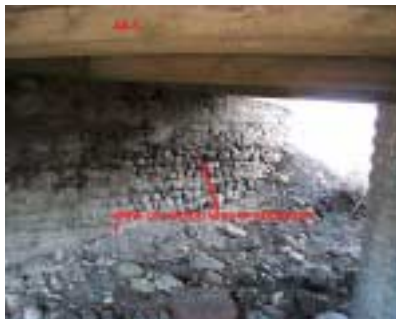
View of Deteriorated Abutment Wall

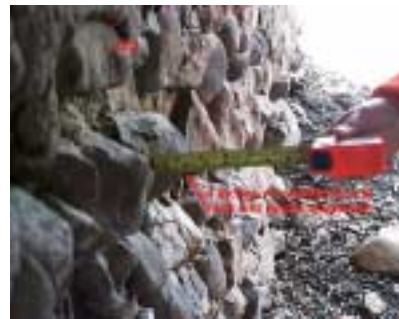
Loss of Pointing in Rubble Abutment

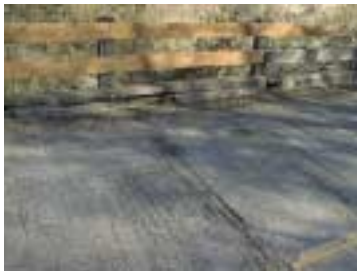
***Deterioration of Wheel Guard & Deck and
Maintenance of Bridge Railing***

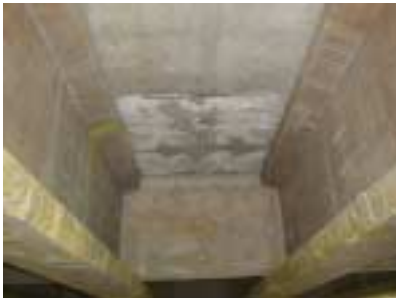
***Exposed Rusty Reinforcing
Steel in Soffit***

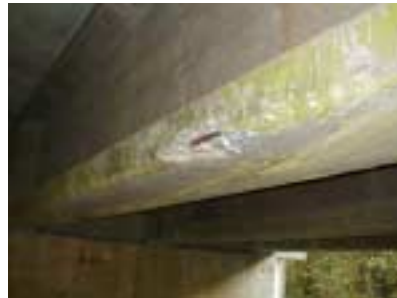
***Exposed Rusty Reinforcing
Steel in Girder Edge***

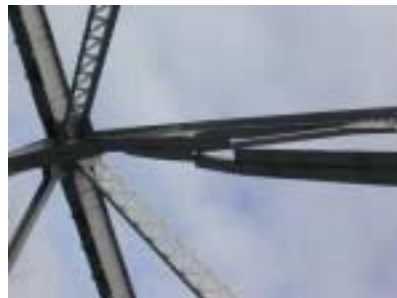
Broken Sway

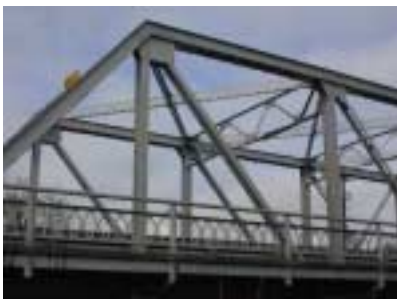
Bent Sways

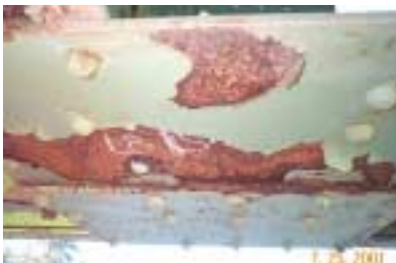
***Failing Paint System with Pack
Rust***

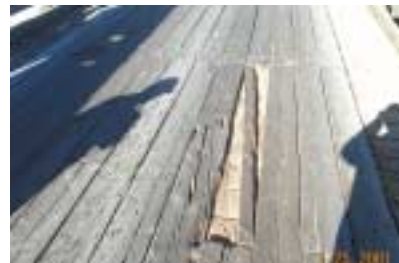
***Running Planks Broken and
Missing***

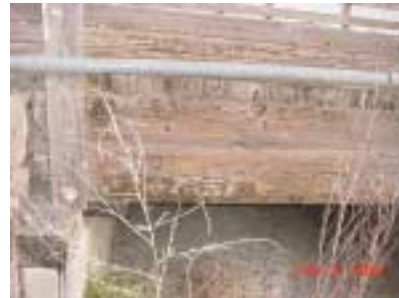
***Stained & Rotted Timber
Members***

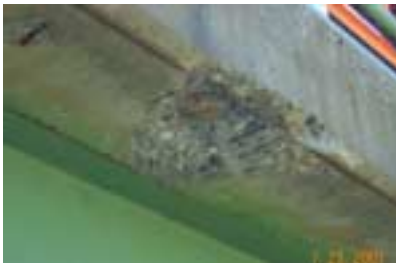
***Typical Spall in Overhang
Under Bridge Rail Posts***

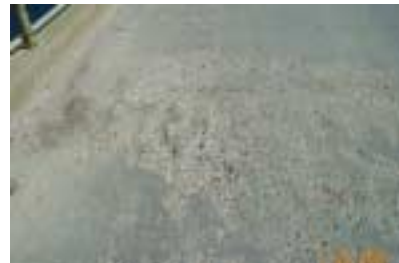
Severe Deck Scale

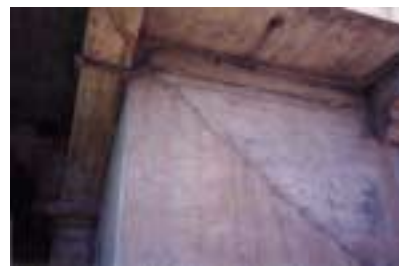
Crack in Abutment

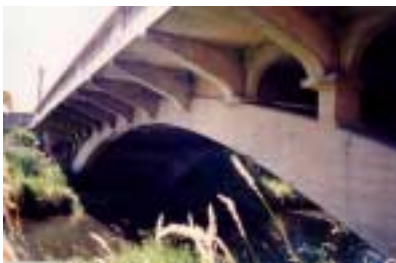
View of Arch Showing Staining of Concrete

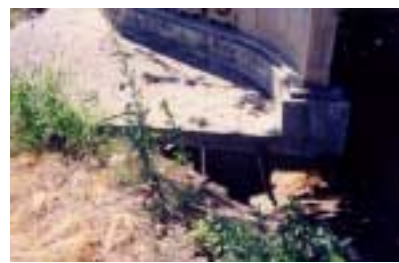
View Showing Undermining at Abutment

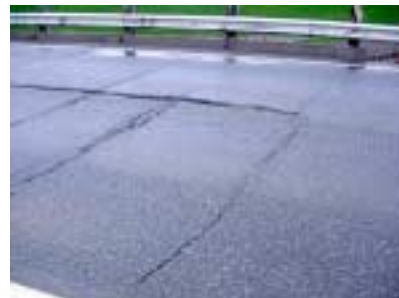
Deck Asphalt Cracking

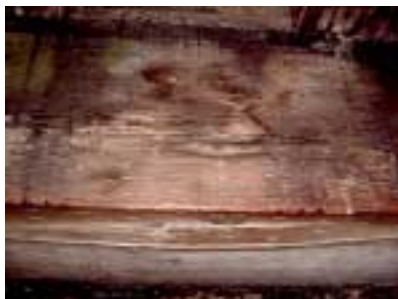
Deteriorated Stained Timbers

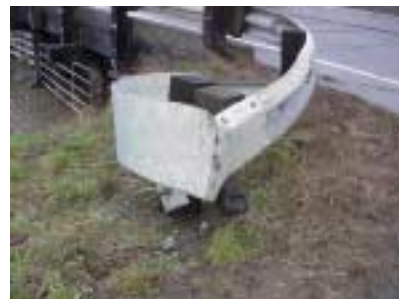
Substandard Damaged Approach Railing

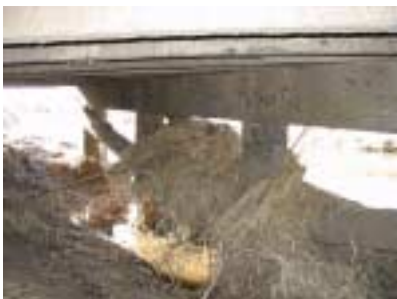
***Fire Damaged Girders & Bent are
Debris Covered and Mud Stained***

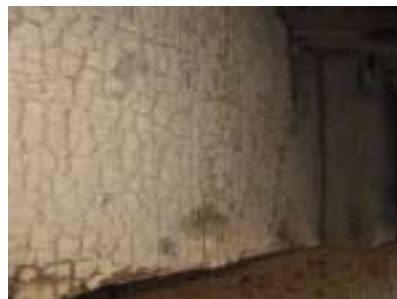
***Fire Damaged and Mud Stained
Timber Sawn Girders***

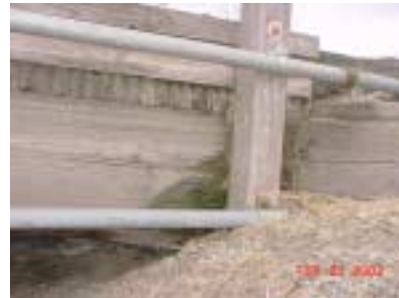
***Stained & Rotten Timber Members in
Contact with Soil***

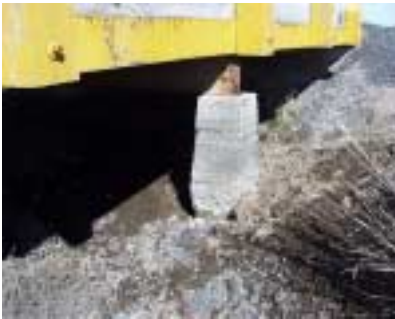
***View Showing Deteriorated
Concrete Column***
